# Parc Solar Caenewydd, Swansea

## Geophysical Survey Report

**Geophysical Survey Report  
for  
Parc Solar, Caenewydd,  
Llewitha, Swansea**

**Magnitude Surveys Ref: MSSS1328**

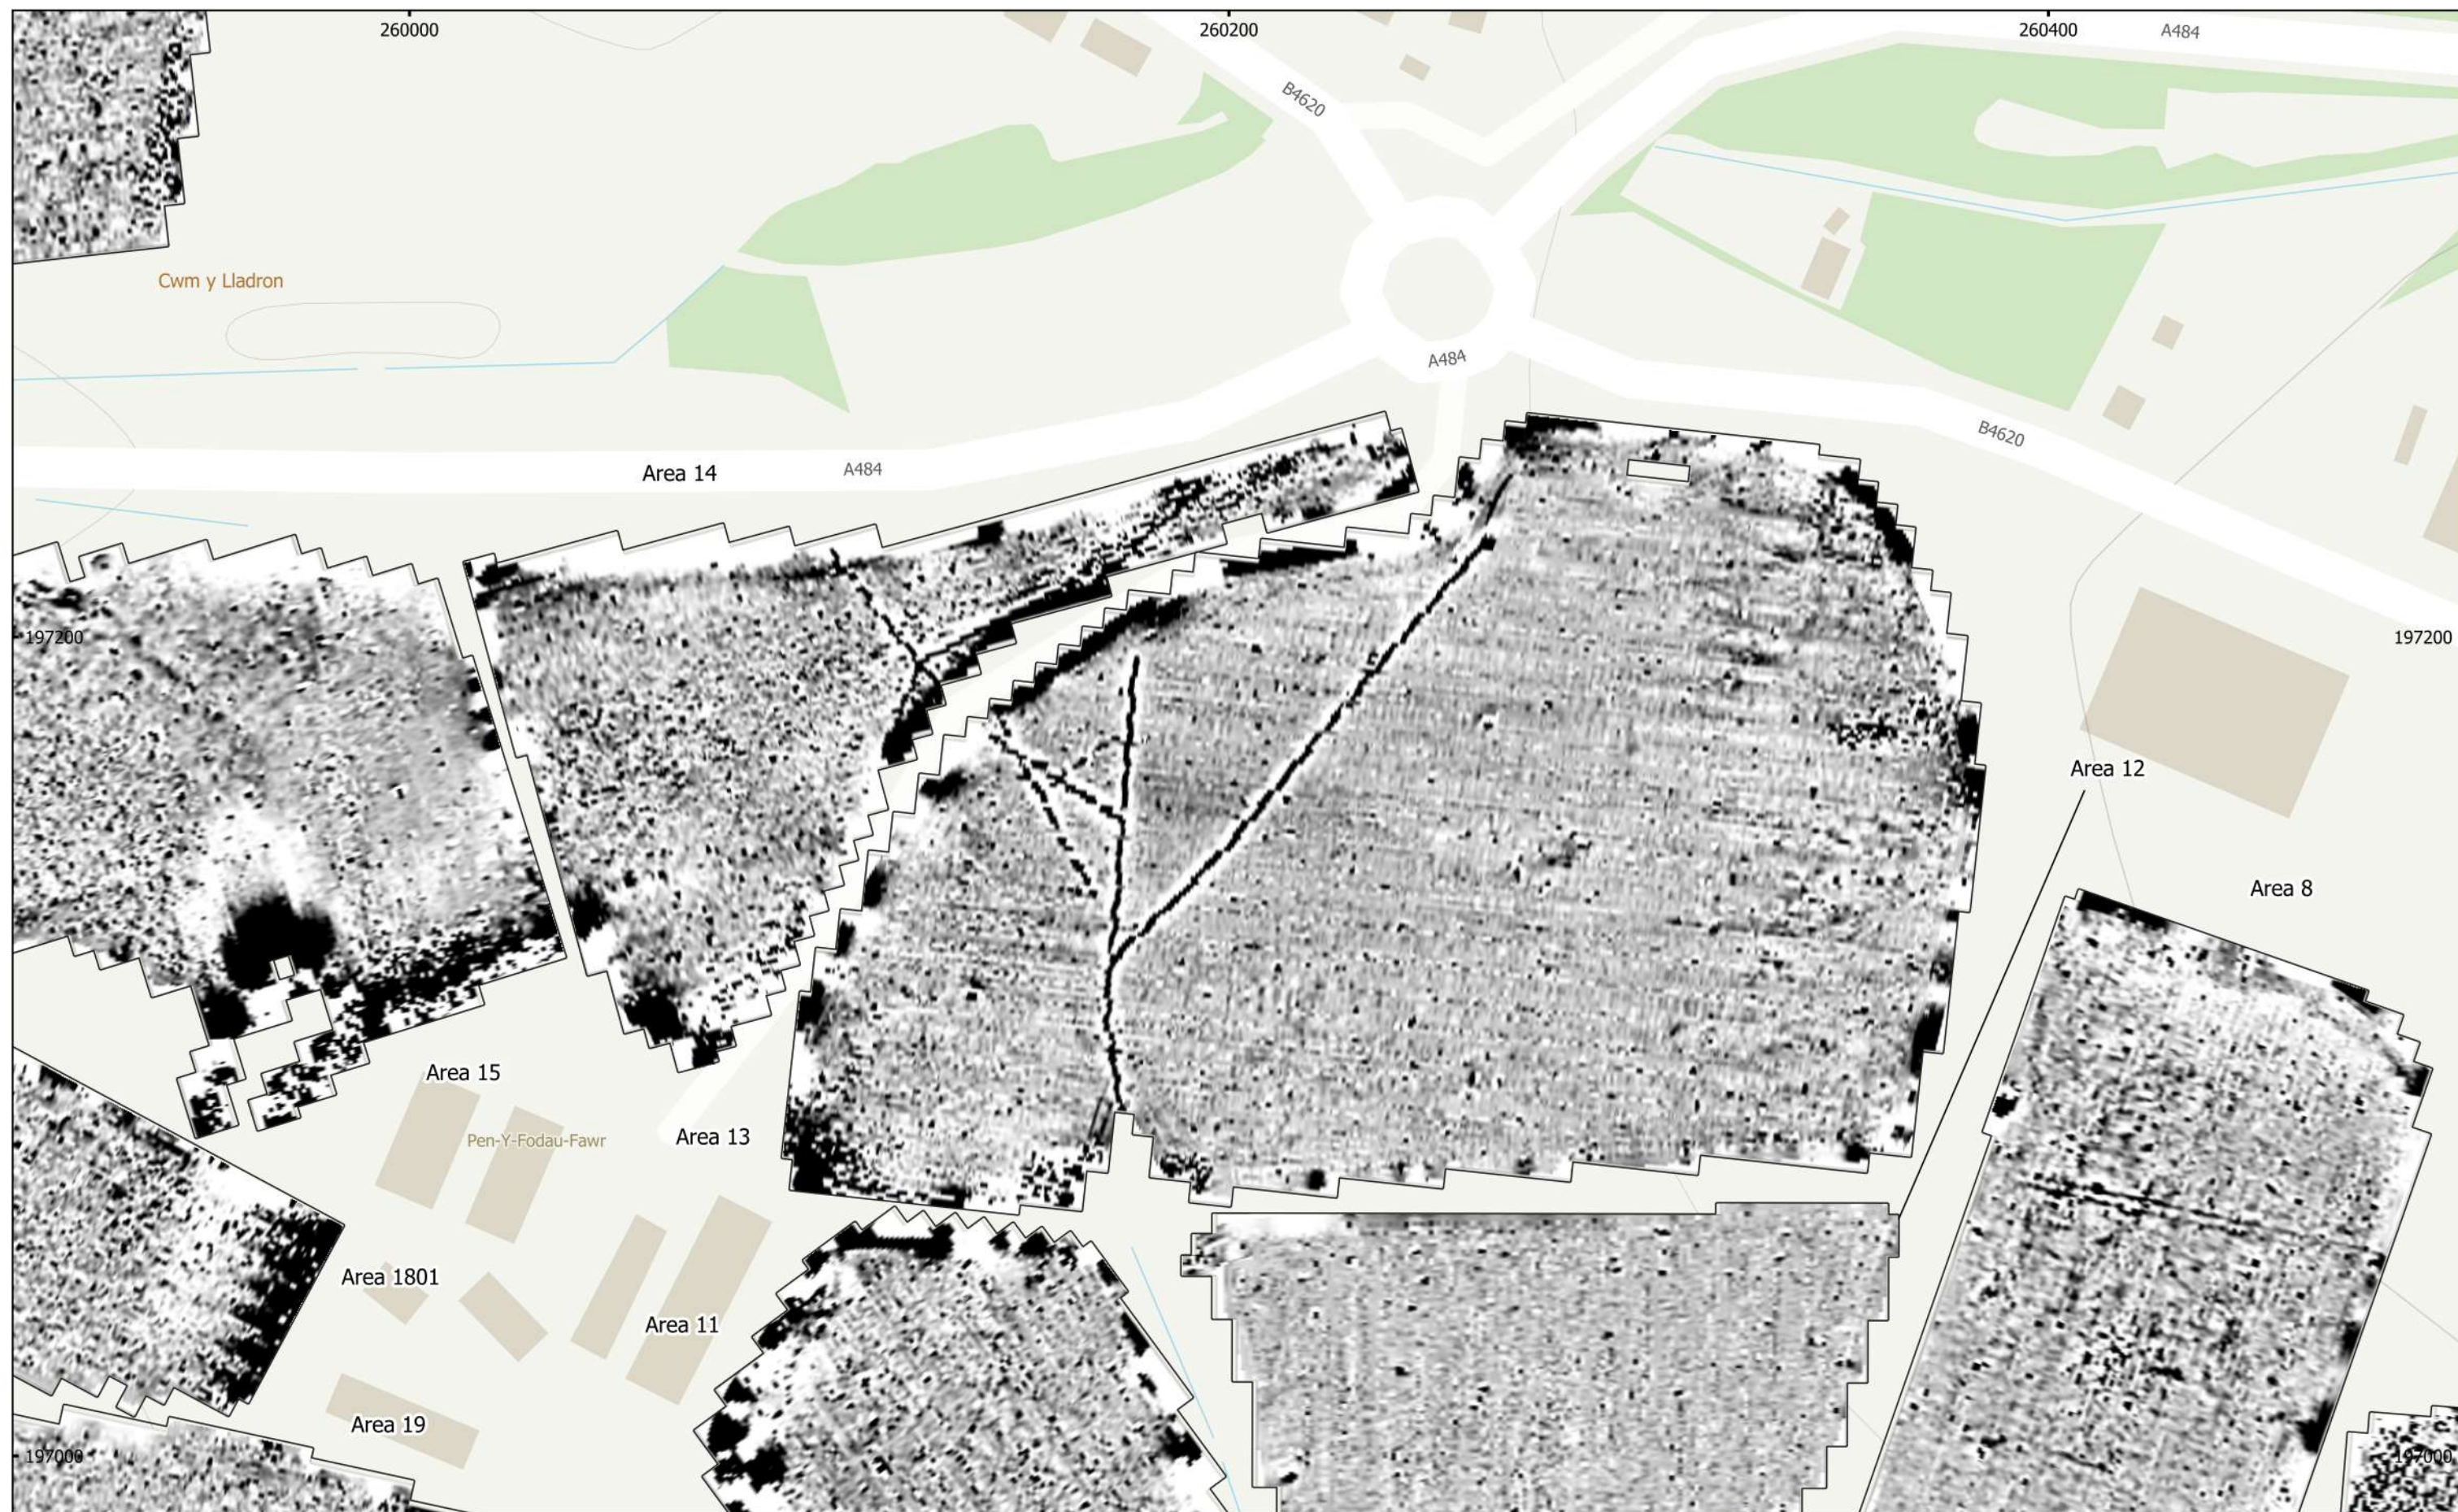
MSSS1328 - Parc Solar Caenewydd  
 Figure 12 - Magnetic Gradient (Areas 8, 11, 12, 13, 14, 15 and 1801)  
 1:1,500 @ A3  
 Copyright Magnitude Surveys Ltd 2022  
 Contains Ordnance Survey data © Crown Copyright and database right 2022

- 7.3.2.1. **Possible Archaeology (Weak)** – Weak rectilinear and curvilinear anomalies have been detected in Areas 13 and 15 (Figures 8 and 12). The morphology and magnetic signal of these anomalies are characteristic of anthropogenic features, in particular possible partial enclosures; however, the anomalies are somewhat obscured by natural background enhancement in Area 15 and by modern inference in Area 13. The anomalies have therefore been categorised as Possible Archaeology.

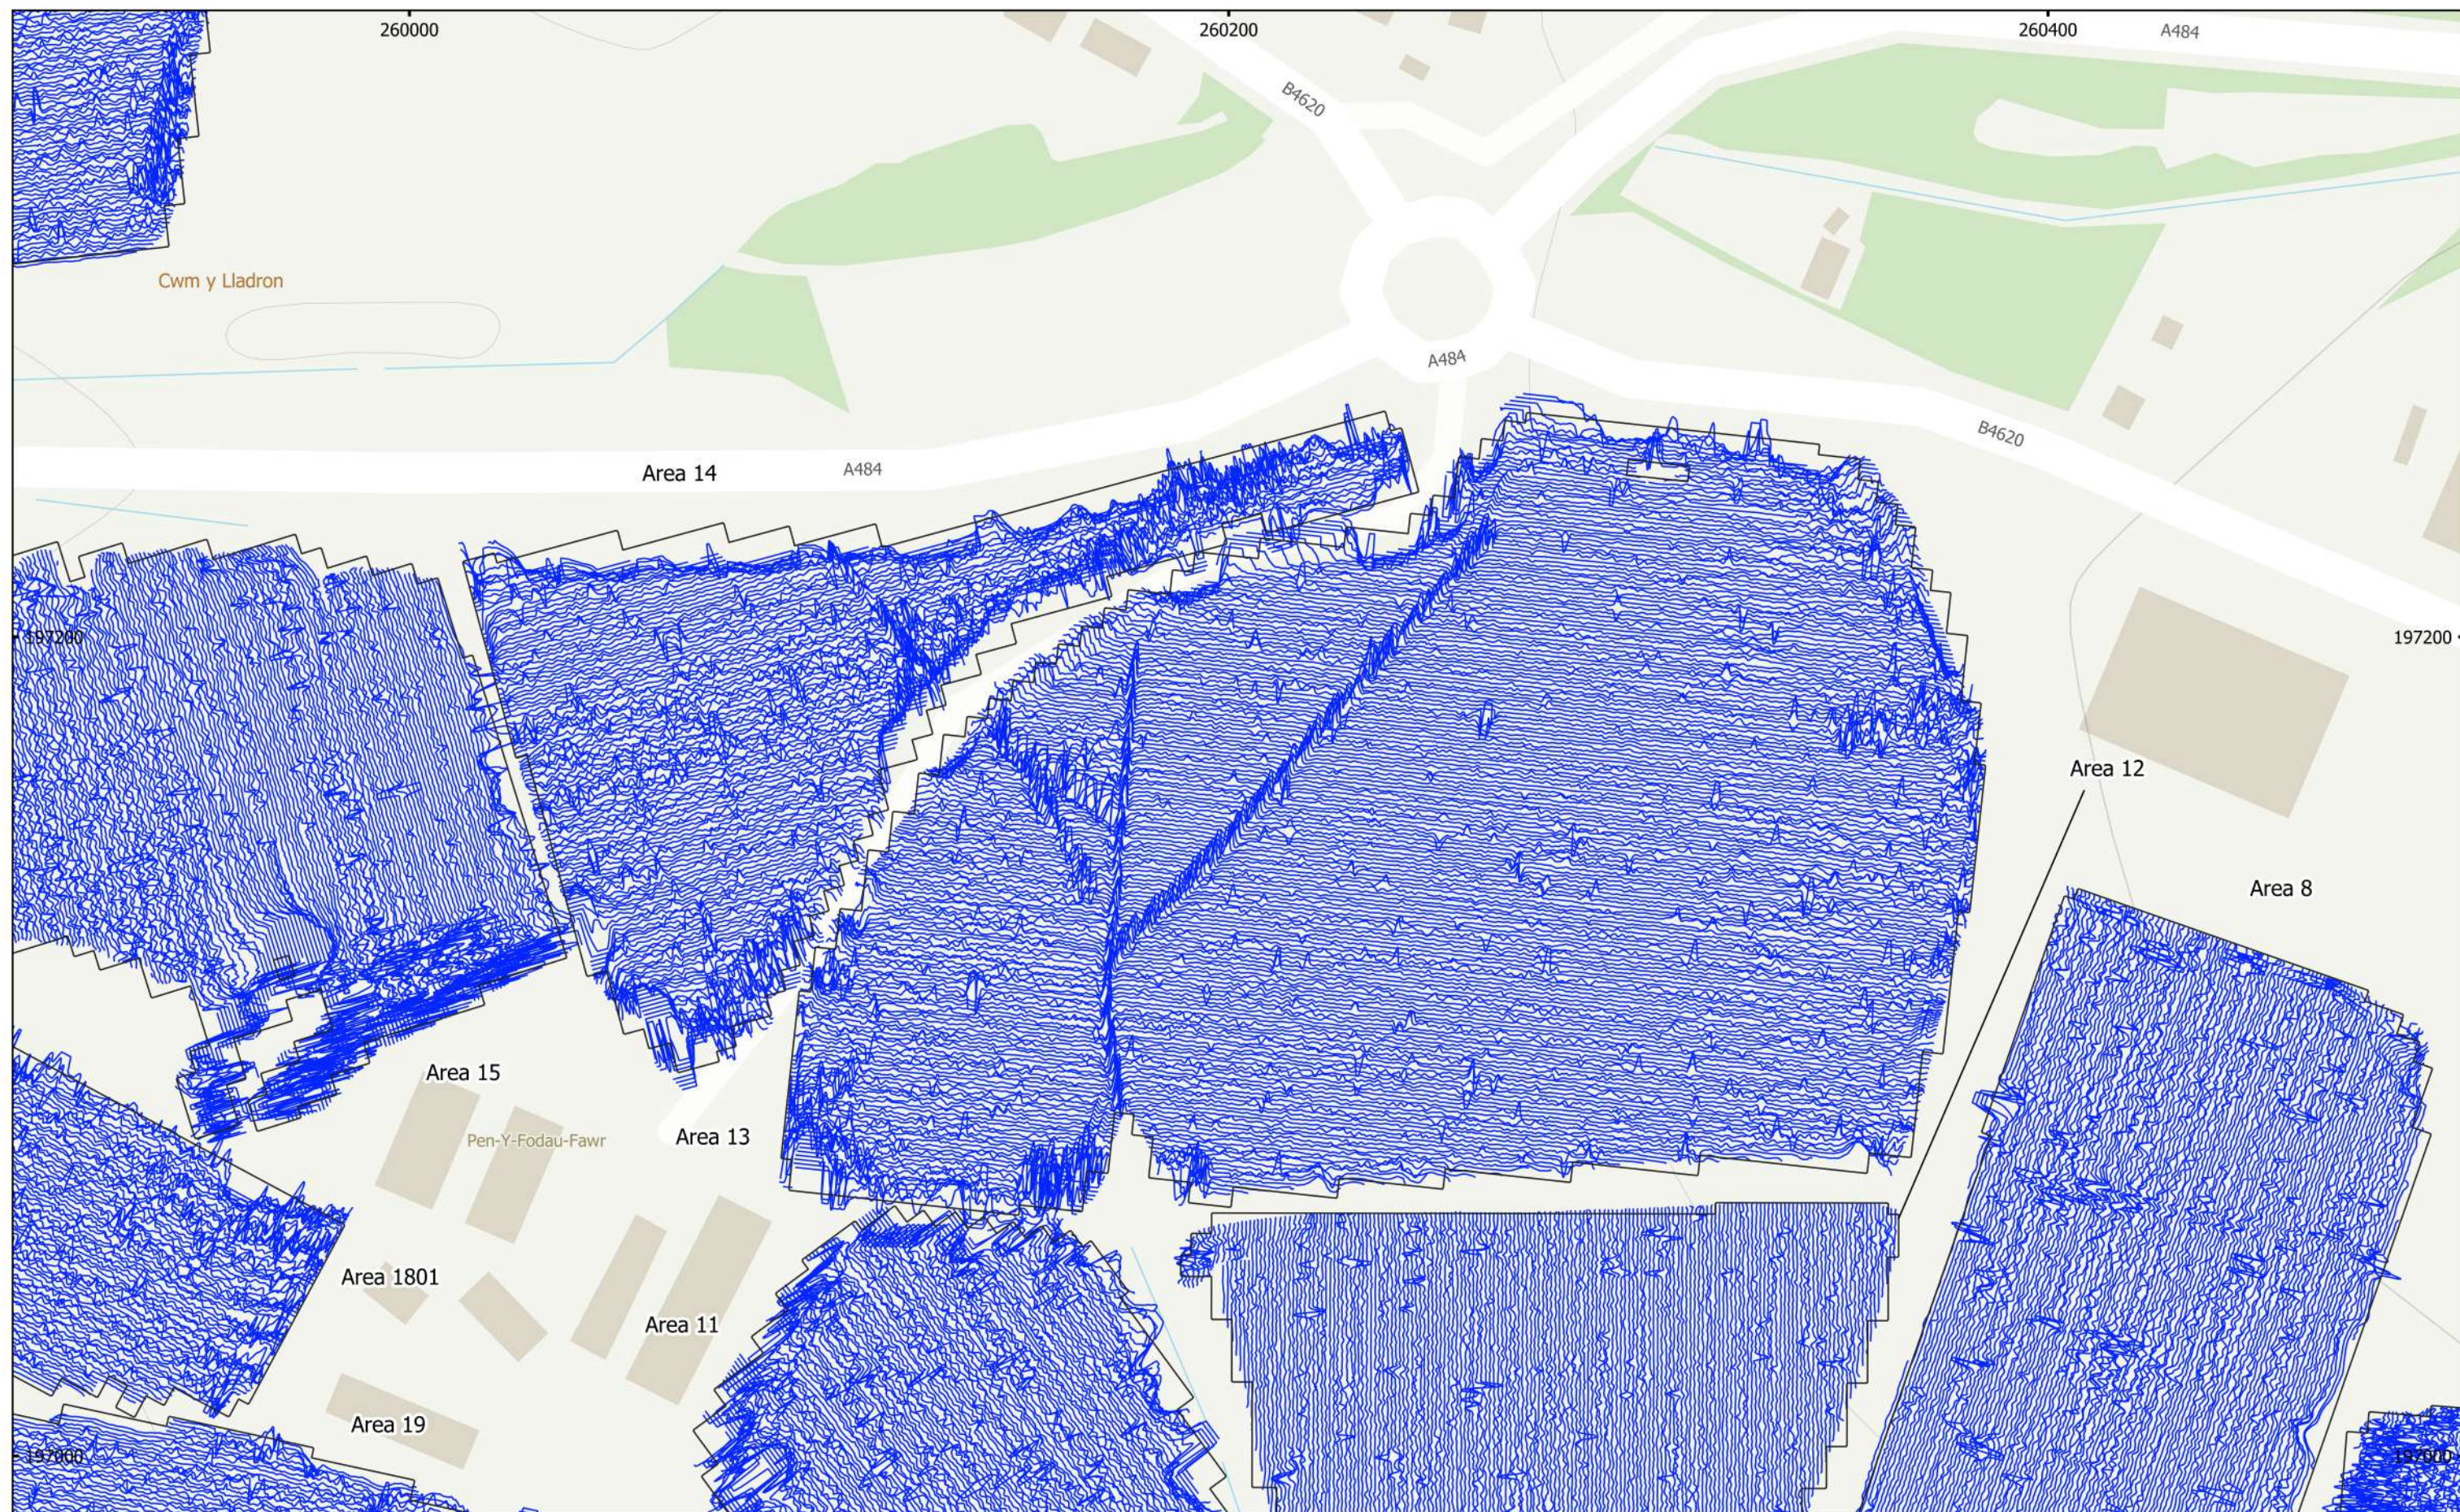
MSSS1328 - Parc Solar Caenewydd  
Figure 14 - XY Trace Plot (Areas 8, 11, 12, 13, 14, 15 and 1801)  
30nT/cm at 1:1,500 @ A3  
Copyright Magnitude Surveys Ltd 2022  
Contains Ordnance Survey data © Crown Copyright and database right 2022

of the survey area includes a former mineral railway running through the south of Area 3 and north of Area 24 and an aqueduct running through the centre of Area 24 which are both visible in historical OS mapping (Figures 4, 6, 14 & 25).

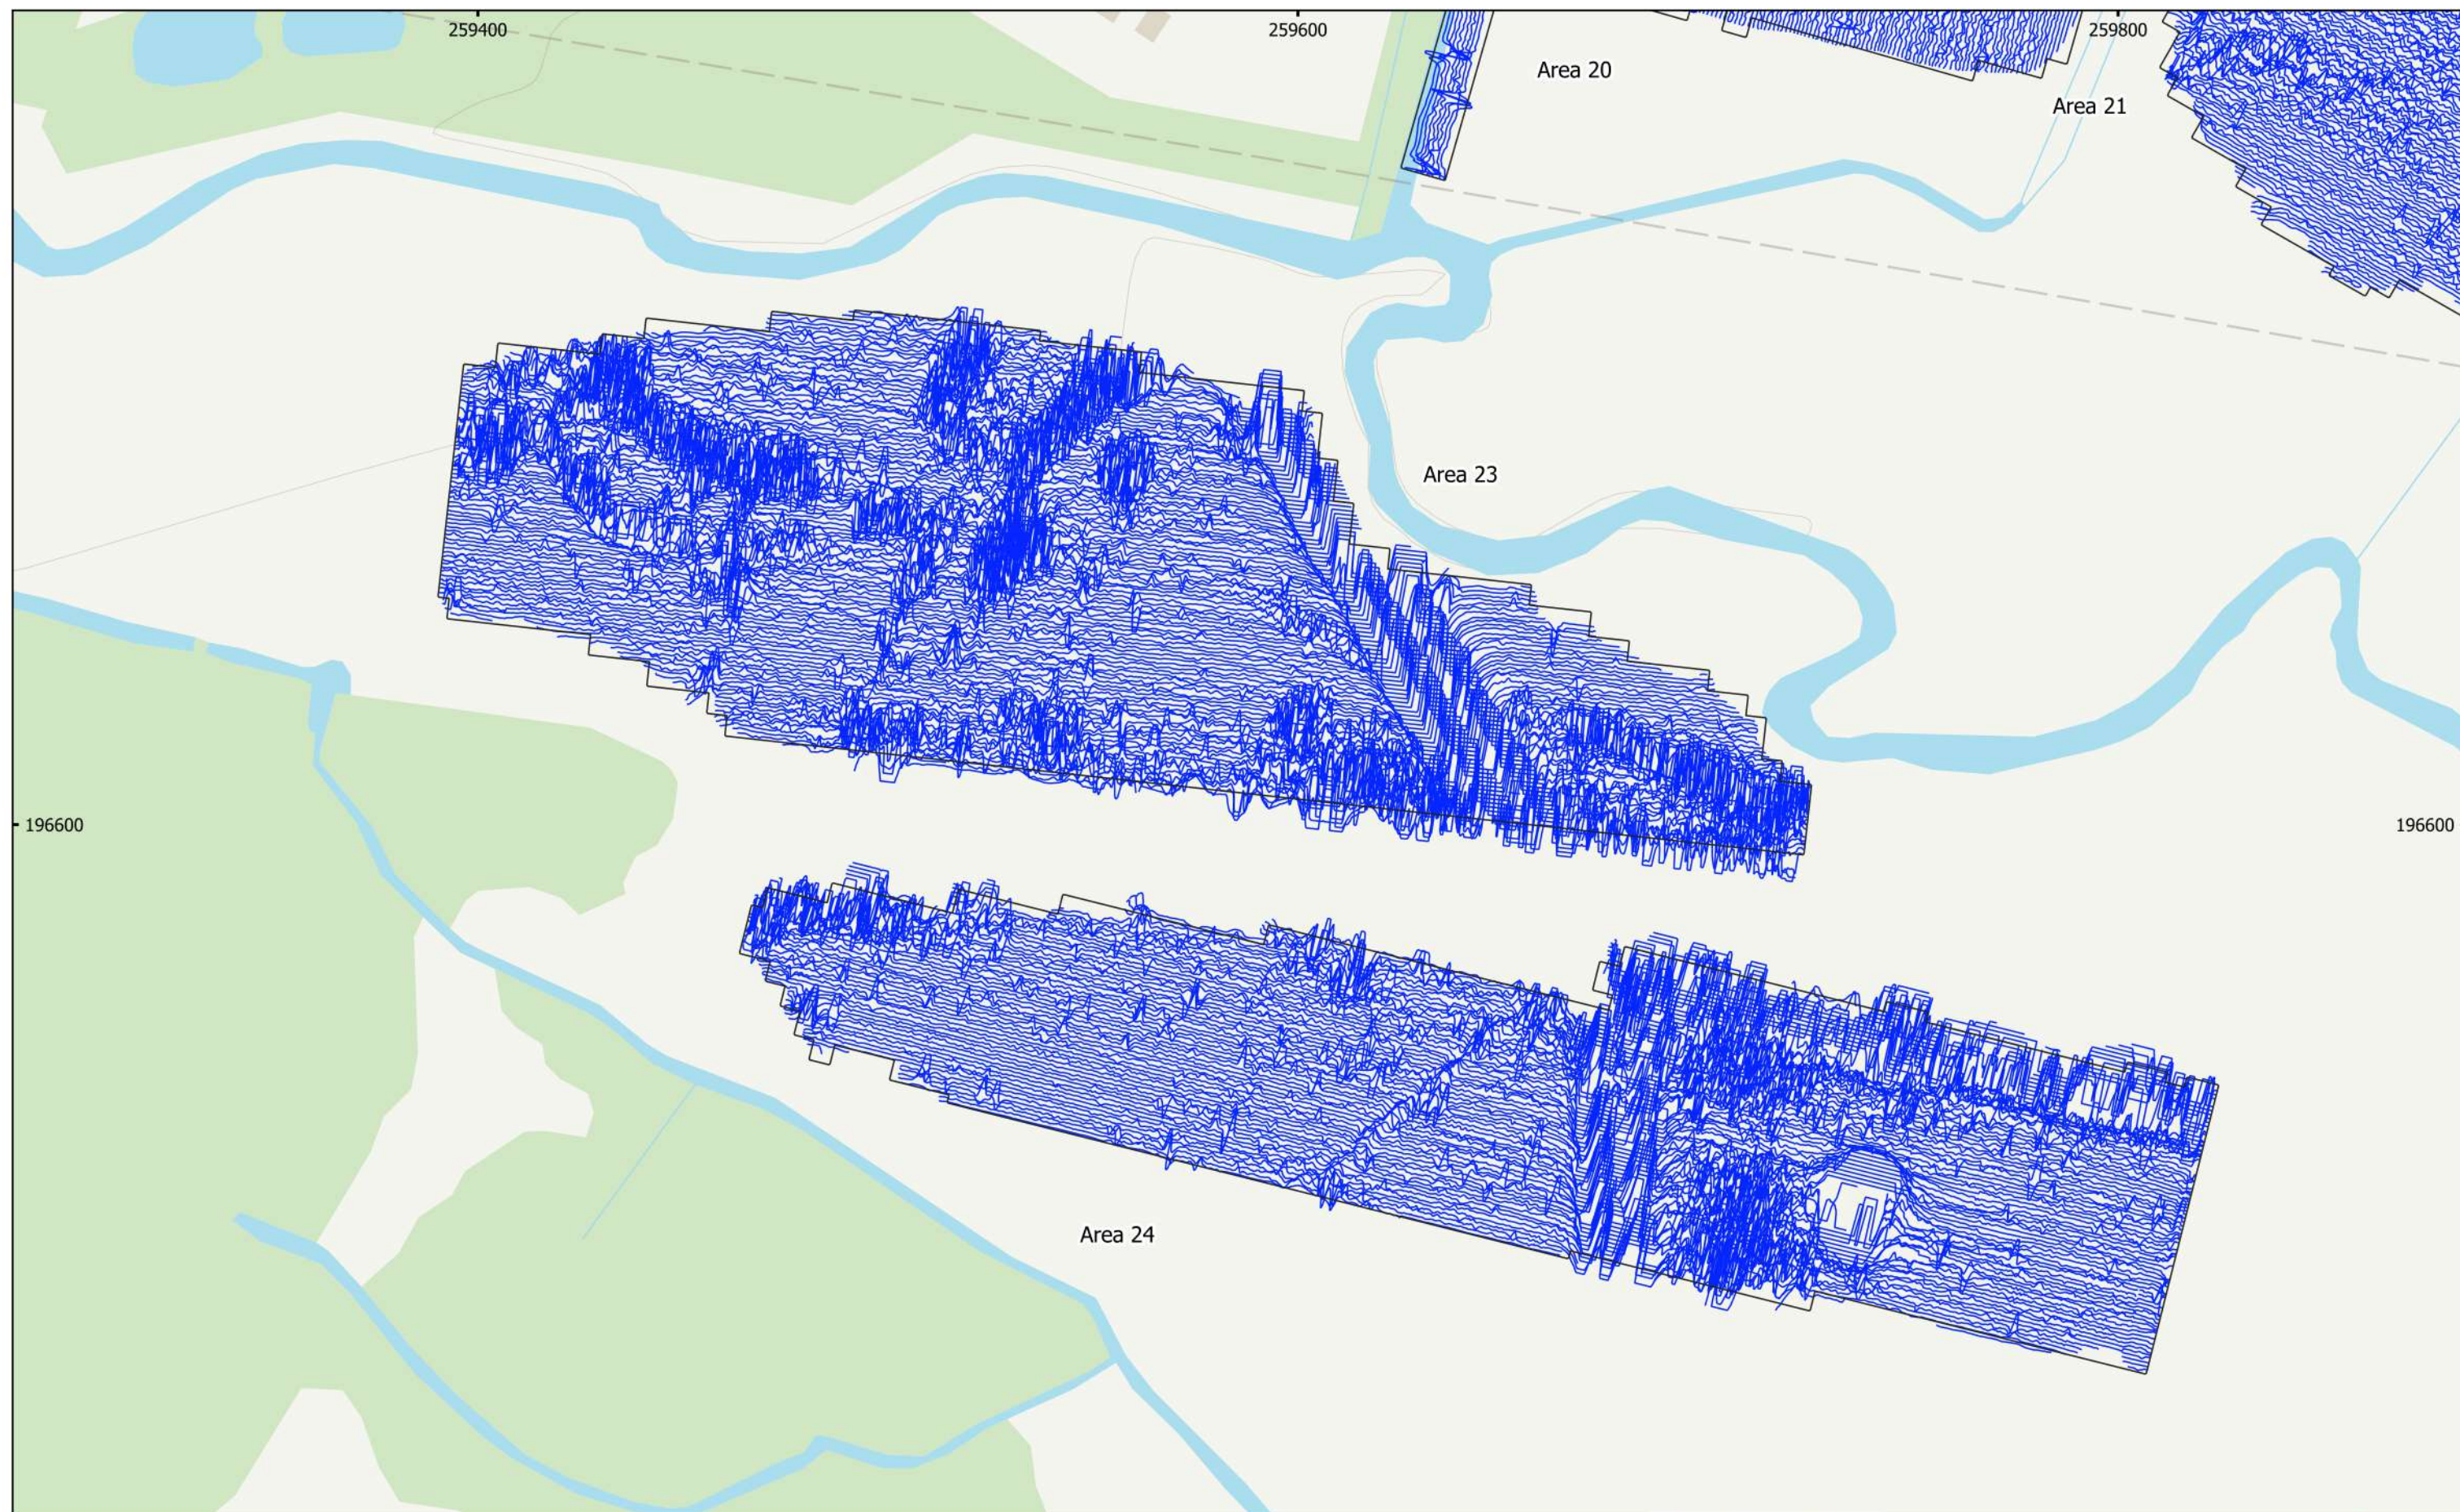
MSSS1328 - Parc Solar Caenewydd  
 Figure 26 - XY Trace Plot (Areas 23 and 24)  
 30nT/cm at 1:1,500 @ A3  
 Copyright Magnitude Surveys Ltd 2022  
 Contains Ordnance Survey data © Crown Copyright and database right 2022

- 7.3.2.9. **Services** – Two sets of parallel, linear, strong dipolar anomalies have been identified within Areas 23 and 24 (Figure 26). The distinct morphology and strengths of these anomalies are typical of buried services.
